PRODUCTION VERIFICATION OF THE
ACOUSTIC EMISSION WELD MONITOR

Final Report

CONTRACT NO. DAAE07-82-C-4116

Chamberlain Manufacturing Corporation
GARD Division
Niles, Illinois 60648

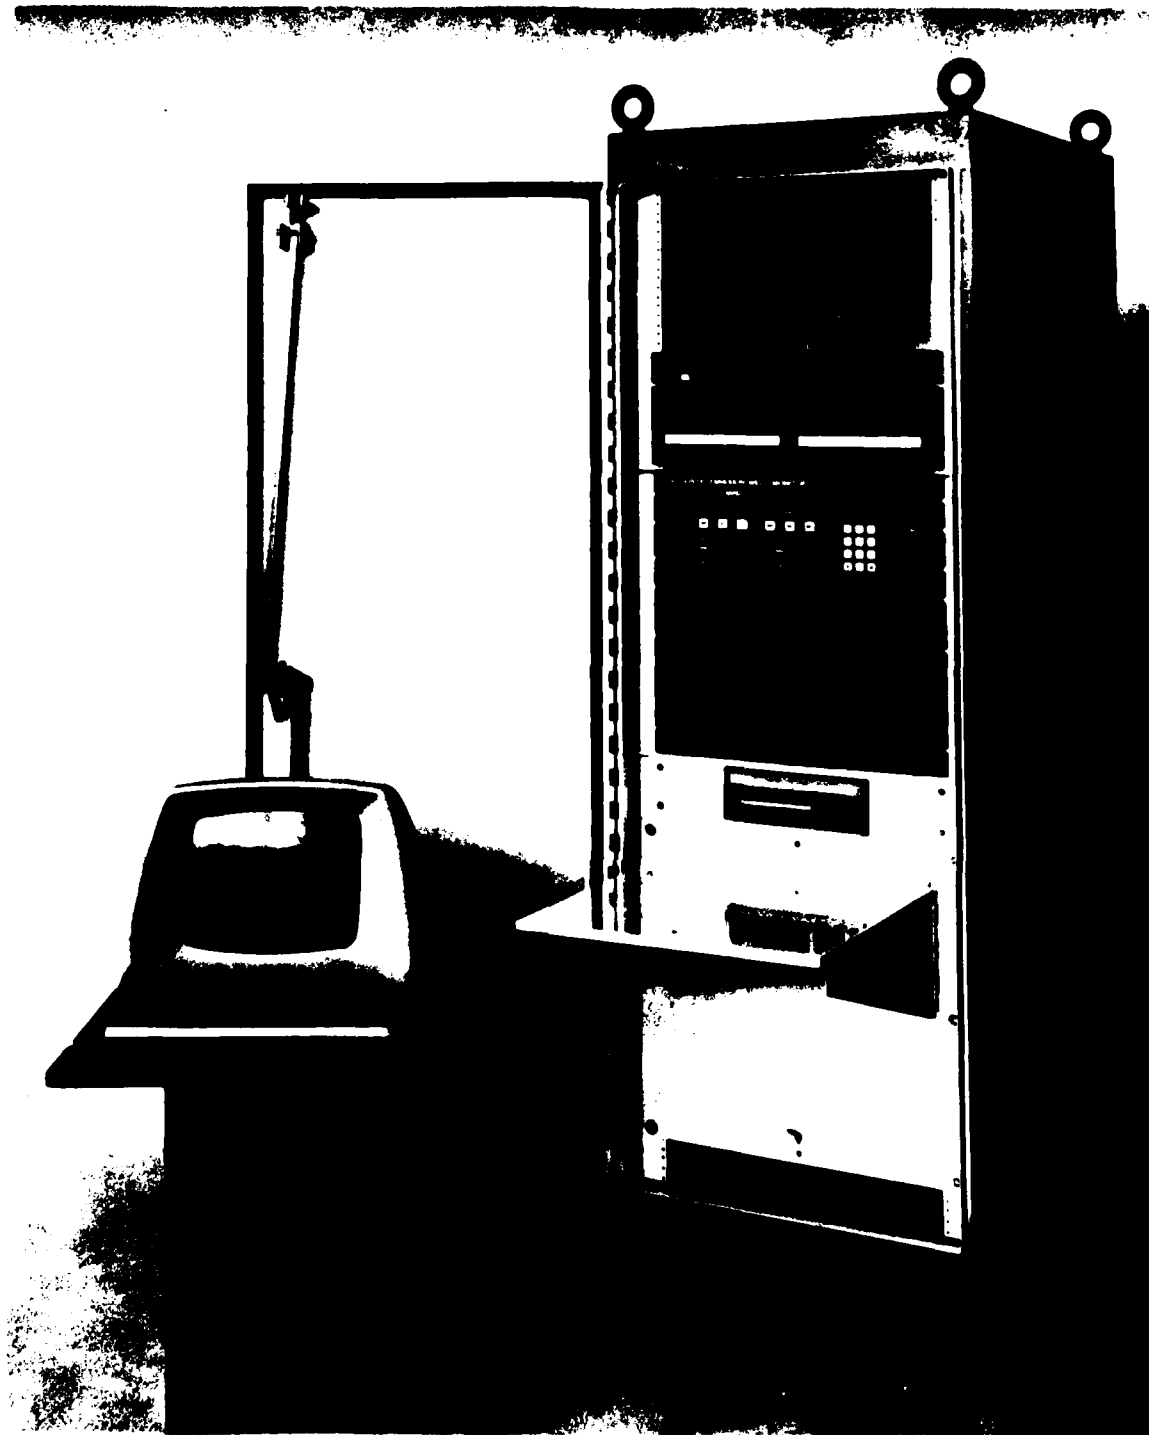
Figure 4.1 PRODUCTION AE WELD MONITOR

Figure 4.1 shows the Acoustic Emission Weld Monitor designed and fabricated for armor plate weld monitoring. The Acoustic Emission Weld Monitor is contained in the large cabinet at the right in the figure. This system uses three Motorola M6800 microprocessors. It has the capability of acquiring multi-channel acoustic emission data and performing the necessary data analysis to allow real-time detection, location, and characterization of flaws in weldments during welding. The system was fabricated for this program with three analog input channels, and incorporates the flaw detection, location, and characterization model evolved in Phase II. The hardware/software configuration includes the following features:

- o flaw pass/location storage for up to 255 Monitor start/stops (i.e., weld passes)
- o flaw characterization storage for up to 64 flaws
- o programming for C/L/IP/P/U flaw characterization (see page 21 for definitions)
- o EPROM-based firmware modifiable with flaw characterization models for special applications
- o remote start/stop capability
- o hardware lock via keyed power switch
- o Three location calibration modes: (a) self-calibration via round-robin transducer pulsing, (b) controlled self-calibration via pulsing of operator selected transducers, (c) manual calibration via operator entry of transducer intervals
- o Three signal processing channels
- o Two channel linear location algorithm
- o One guard channel
- o NEMA-12 type industrial cabinet
- o self-contained printer which lists flaw occurrence, location, type and relative size for each weld pass after pass completion

- o high temperature transducers (5)
- o magnetic hold-down assemblies (4)
- o transducer preamplifiers (5)
- o industrial-grade cables (6)

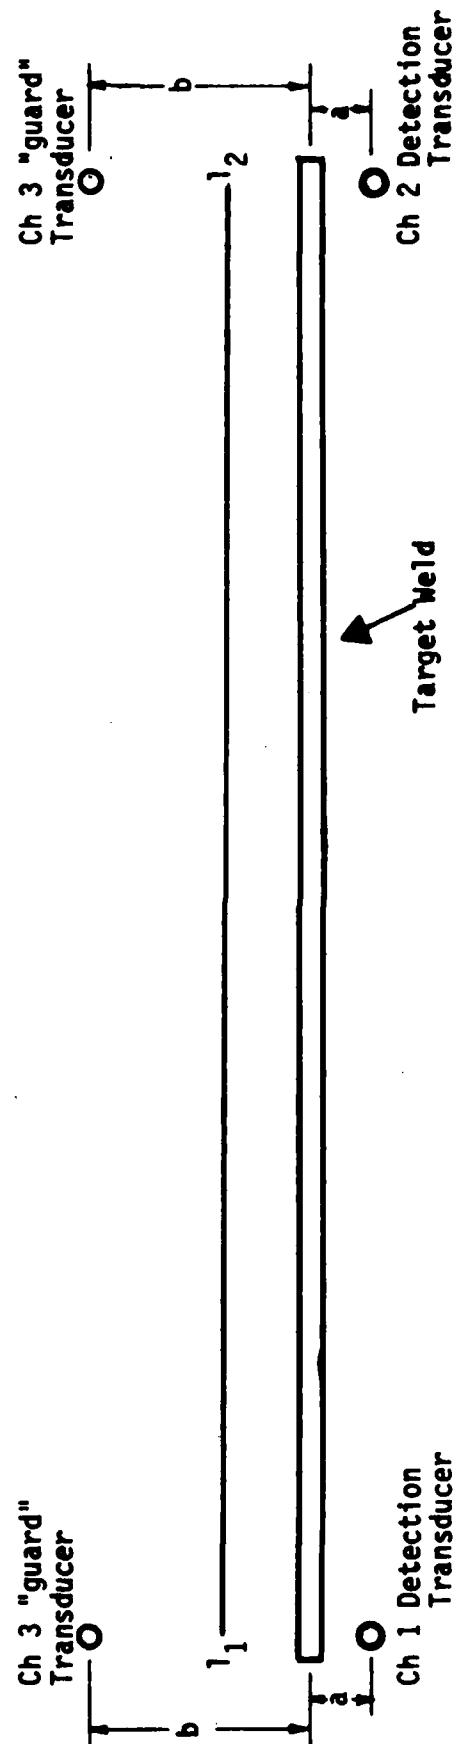
Figure 4.2 SCHEMATIC DIAGRAM OF GUARD BAND TRANSDUCER LAYOUT

In the diagram, note the line ($l_1 - l_2$) joining the midpoints between the channel 1 transducer and its associated channel 3 "Guard", and the channel 2 transducer and its associated channel 3 "Guard". By geometric considerations, sound originating above the line will arrive at one of the Guard transducers before reaching transducer 1 or transducer 2 (Reject Zone). Sound originating from any point below the line will arrive at transducer 1 or 2 before reaching either of the channel 3 transducers (Accept Zone).

As long as $b > a$, any AE originating from target weld will arrive at Ch 1 or Ch 2 before arriving at Ch 3.

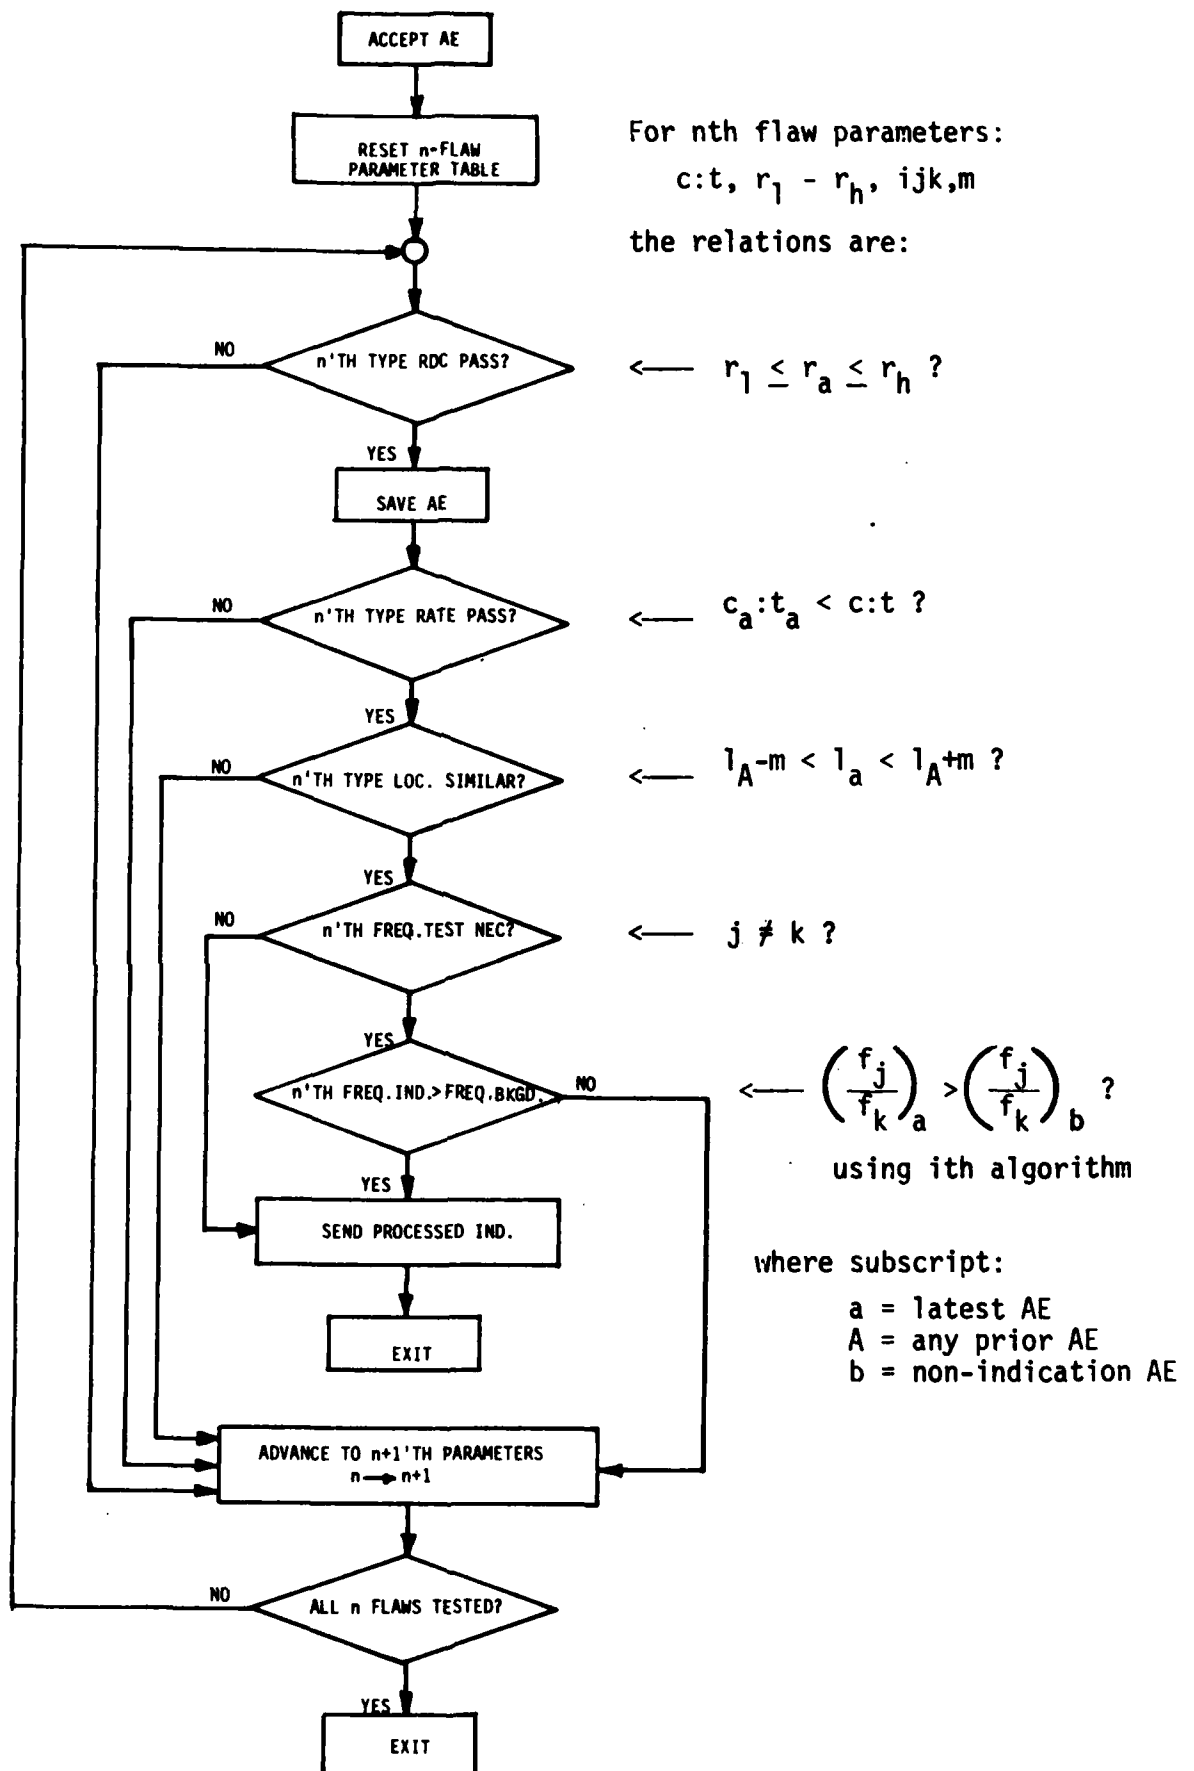
Figure 4.4 GENERALIZED DISCRIMINATION ALGORITHM

The Flow Chart in Figure 4.4 shows the procedure by which the AEWm processes acoustic emission signals for flaw detection. The AE signals are subjected to three successive tests: energy or ringdown count limits, rate limits (AE bursts), and location tolerance. The parameter c is the number of energy-qualifying events required to initiate the flaw detector's rate test. The parameter t is the time in seconds into which all c events must fall for flaw detection. The limits r_l - r_h are, respectively, the lower and upper ringdown counts that create the energy qualification window. The number i is the algorithm described in Figure 4.3. The number j specifies which frequency band (described later in this section) is used in the flaw characterization process; the k defines the normalization frequency band, which is usually selected to

be the peak AE transducer response. The last number, m, is the locational tolerance used, it assures that all events being considered for a flaw indication must be from the same location \pm the specified tolerance.

The flaw detection model found to be optimal for this work is quite similar to the model GARD has found to be optimum for a wide range of welding processes and materials. The detected acoustic emission events are subjected to three tests as shown in Figure 4.4. The parameters that proved optimum, based upon Phase II work are:

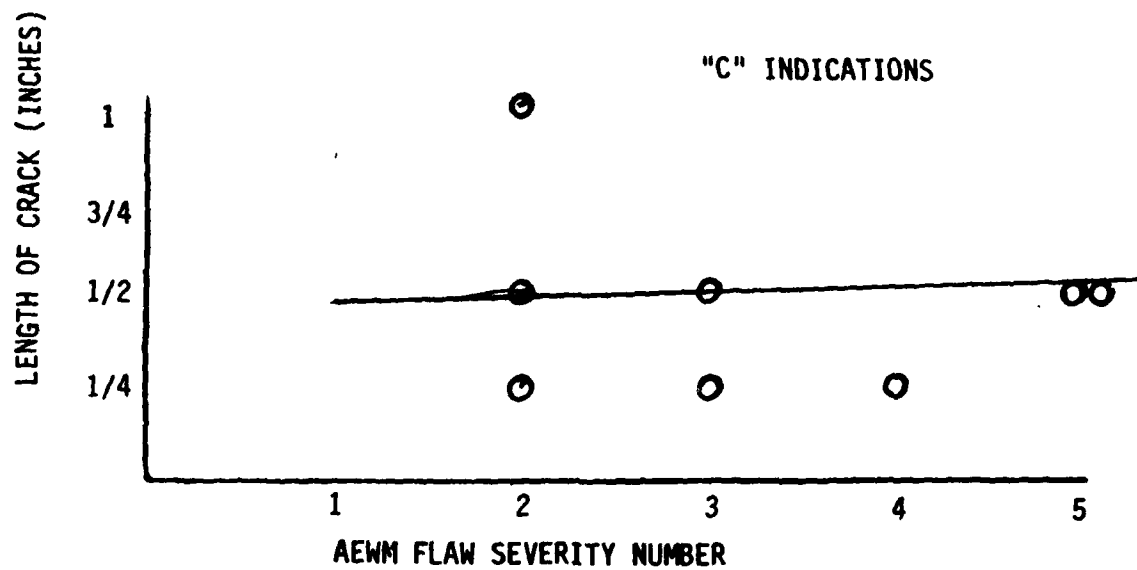
Figure 5.2 LENGTH OF CRACK VERSUS AEW SEVERITY NUMBER

Figure 5.2 is a plot of all "C" AE indications. In this case, they all happen to be cracks by standard NDT definition. The figure shows "actual" crack size vs. the C-related AE intensity number. Severity numbers seem to be independent of crack size. Based on data from the delayed cracking study as presented in Section 6, this relationship is due to the ringdown count windowing (96-1008) used in the production monitoring AE model. The AEWM is apparently looking at tails of

AE signals and not at peaks from these "macro" cracks. It is expected that raising the top of the energy window (i.e., 1008-4080), will allow the intensity number to provide a better indication of macro-crack size.

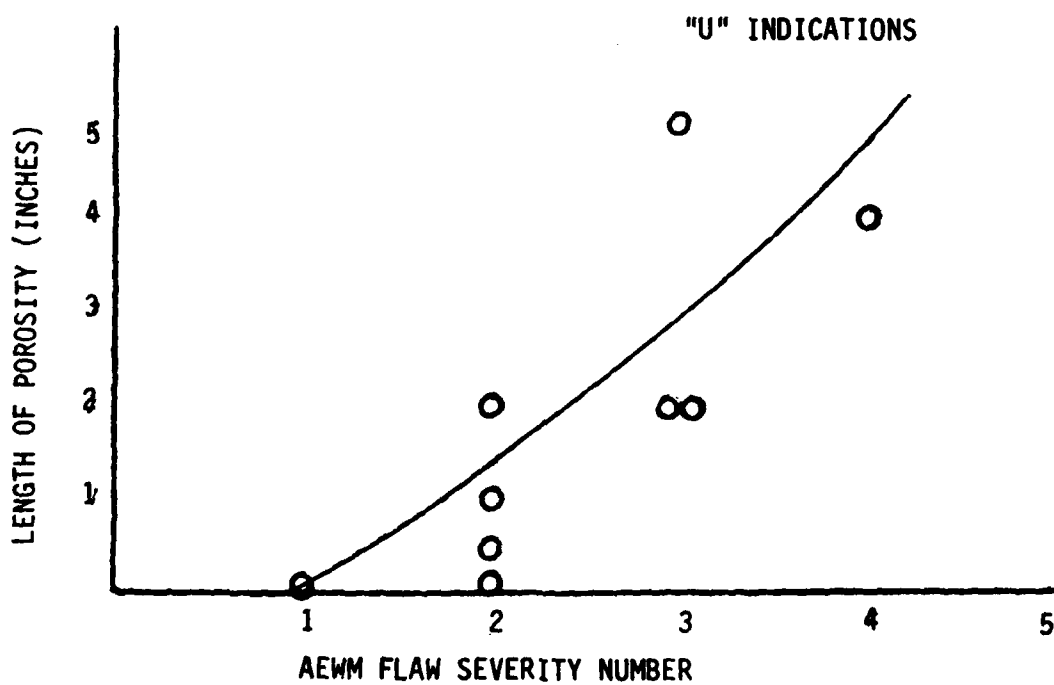
Figure 5.3 LENGTH OF POROSITY VERSUS AEW SEVERITY NUMBER

Figure 5.3 is a plot of all U indications. They all appear to be acceptable (small) porosity by standard NDE definition. There seems to be a rough relationship between intensity number and size of these porosities. This is probably due to the detection of micro-cracking associated with the porosity (i.e., more porosity, larger micro-cracking). The low energy released during micro-cracking is within our model window (96-1008), thus flaw sizing is realized.

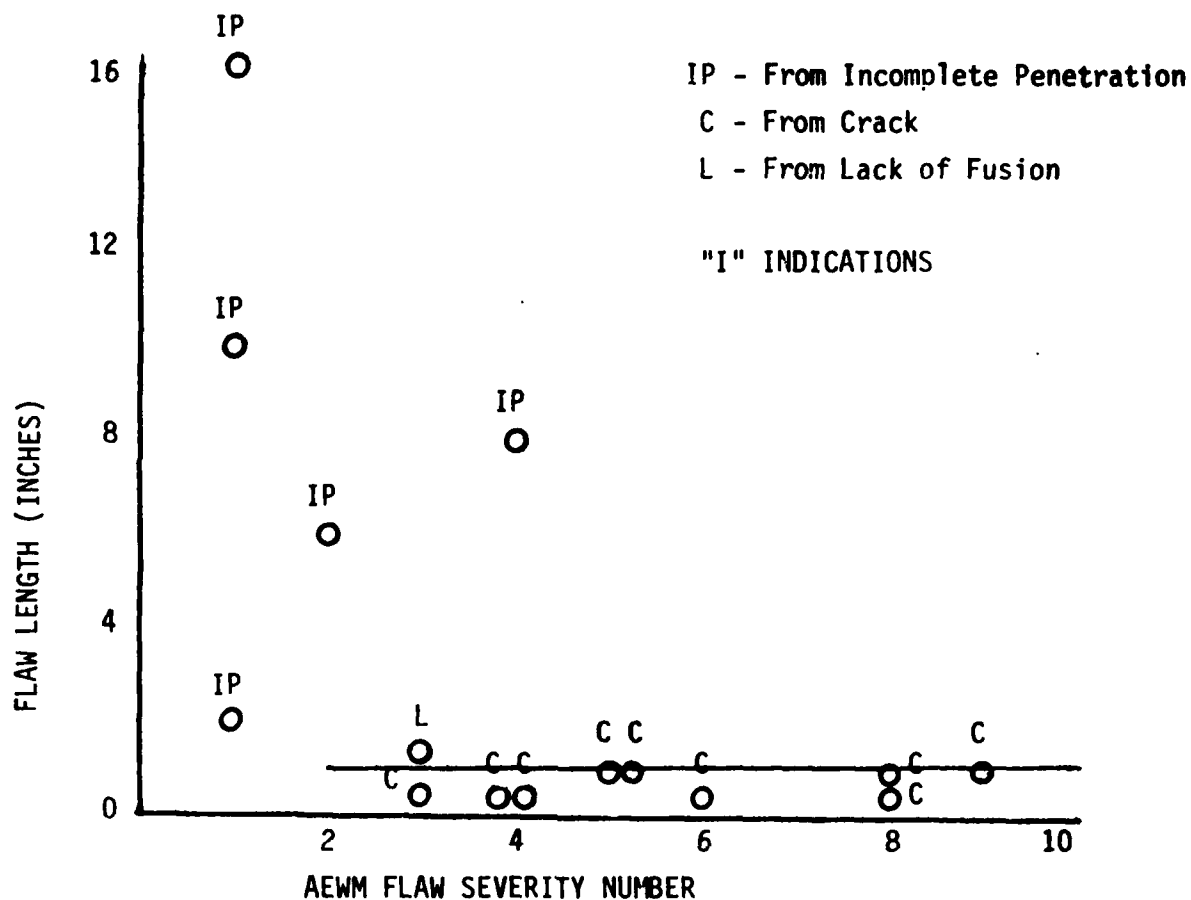
Figure 5.4 LENGTH OF INCOMPLETE PENETRATION VERSUS AEW FLAW SEVERITY NUMBER

In Figure 5.4 we see that the intensity numbers for cracks as defined by standard NDE show a flaw size flatness similar to Figure 5.2 for cracks.

This is to be expected since I is the same model as C (except for pass number). Both do 100 percent in identifying cracks as "Cracks". The independence of severity number appears to be due to the previous explanation: the "C" severity numbers' insensitivity to crack size.

The intensity numbers from incomplete penetration, as defined by standard NDT, do not give any correlation to flaw size. The non-correlation with size is conjectured as due to the fact that these AE indications are from small cracks at the ends of the incomplete penetration, while the sizes plotted are the actual extent of the incomplete penetration itself. Note, these indications are mostly low numbers (4 of 5 have an intensity number of 2 or less), lending credence to the presence of small cracks, and thus further support our micro-crack hypothesis presented above.

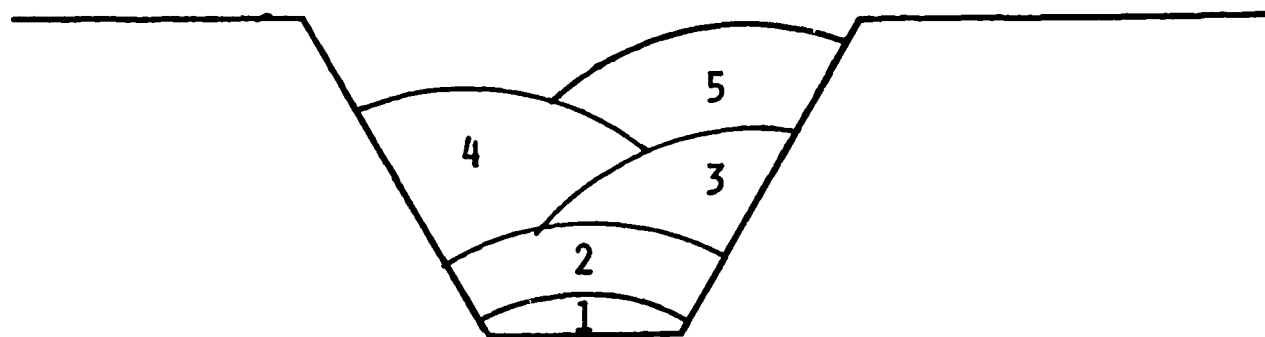
Figure 6.2 WELD BEVEL AND PARAMETERS FOR AE DELAYED CRACK LABORATORY WELDS

PASS	AMPS	VOLTS	TRAVEL SPEED
1	300	26	13½ ipm
2	300	26	13½ ipm
3	300	26	13½ ipm
4	300	26	13½ ipm
5	300	26	13½ ipm

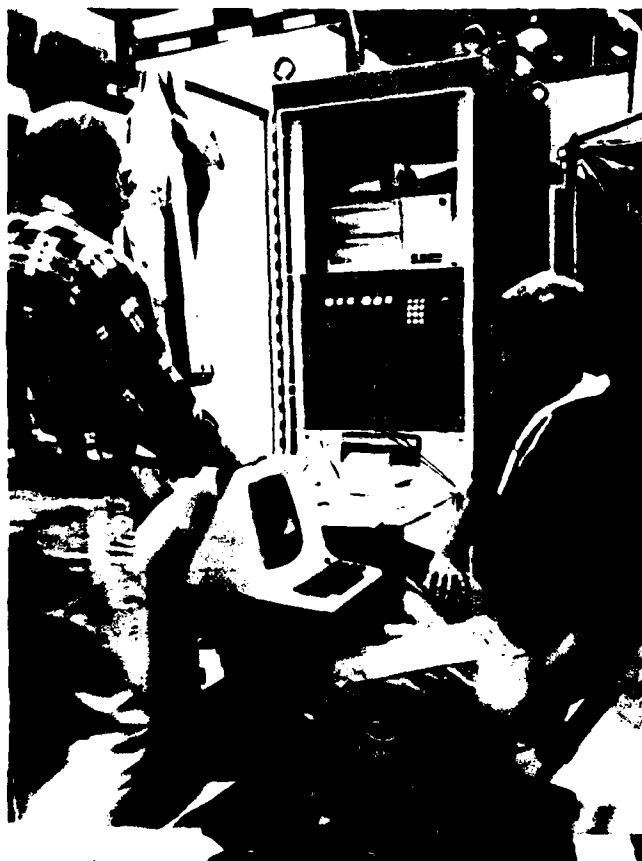
Figure 6.3 TEST SET UP FOR AE DELAYED CRACK
SIMULATION EXPERIMENTS

Figure 6.3 shows the test setup in General Dynamic's MM&T Weld Laboratory. Figure 6.4 shows a close-up of a typical test plate with the AE sensors attached at each end of the weld.

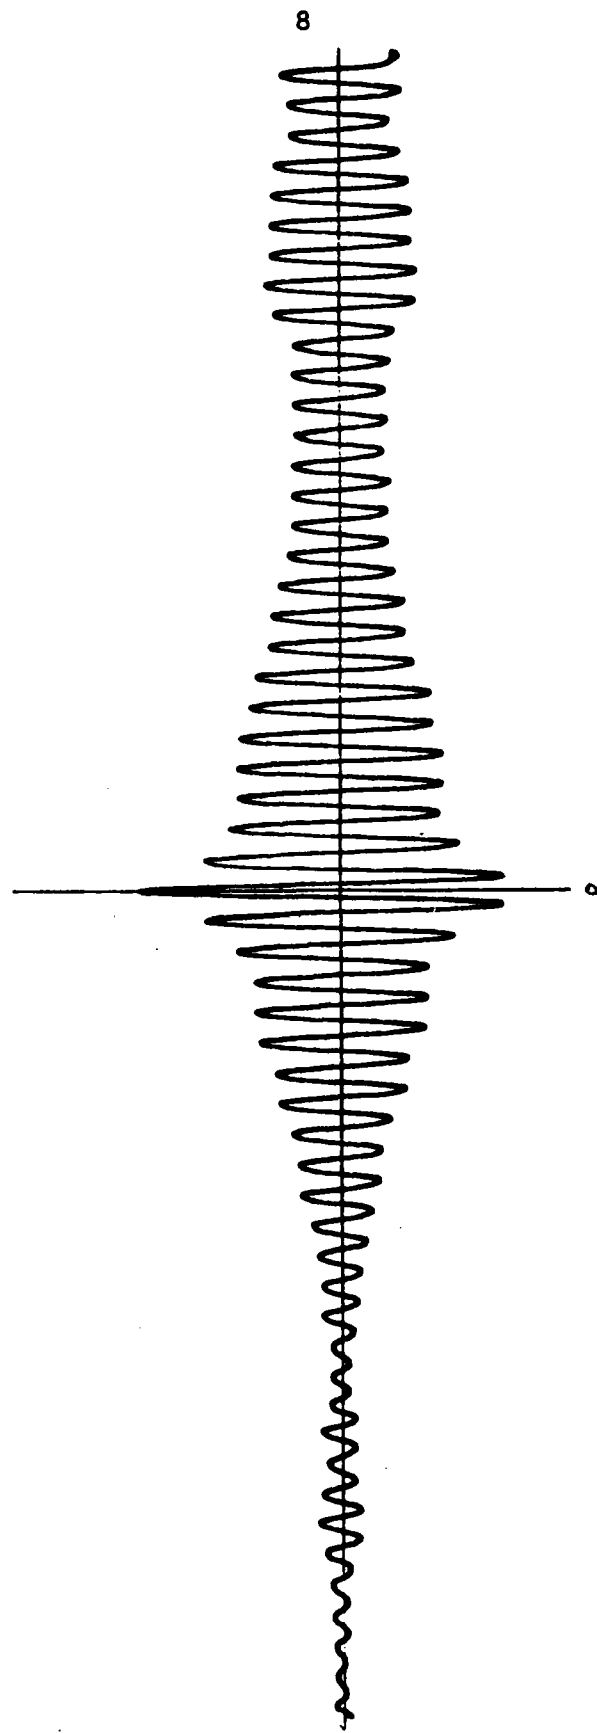
Autocorrelation Plot
Chipping Hammer AE
AET-375 (3313)
800 kHz LPF
3 mHz Sampling

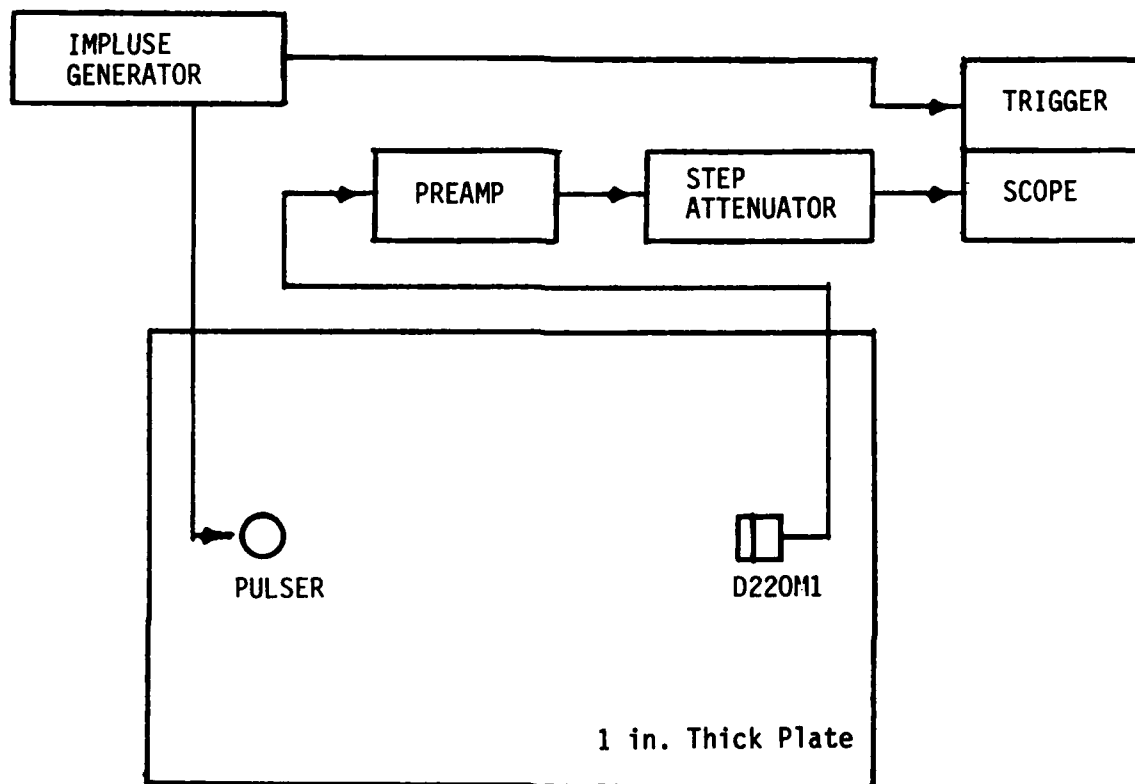
Figure A-1 TEST SET UP FOR DIRECTIONAL SENSITIVITY MEASUREMENT OF D220M1

The results of the experiment showed peak sensor response in the forward direction. Maximum signal rejection (-5db) occurred when the acoustic emission signal source was located along the welds where simultaneous grinding might be expected during weld monitoring with the AEWM. This low signal rejection was not sufficient to overcome the acoustic grinding noise generated while simultaneously monitoring a weld for flaws.
